Bulletin BPI 06-13

Subject: Pedal pulsation after brake service

Vehicle Involved: All vehicles with hub-less rotors.

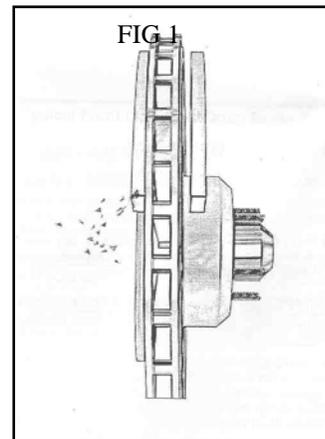
2. With excessive run-out, the rotor wobbles as it turns (Fig.1). Uneven rotor wear occurs when the brake pad contacts the high side of the rotor causing rotor thickness variation. Thickness variation causes:

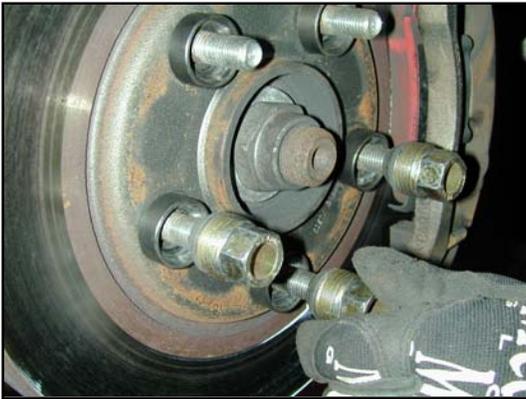
Fig.2

3. How do I check rotor run-out? (Fig.2 & 3)

- Check bearing for excessive play
- Clean hubs and rotor hat
- Install conical cone washers
- Torque lug nuts in sequence
- Secure dial indicator
