Bulletin BPI 13-06

Subject: Safety issues using lightweight rotors

Condition: Catastrophic examples when rotors fail

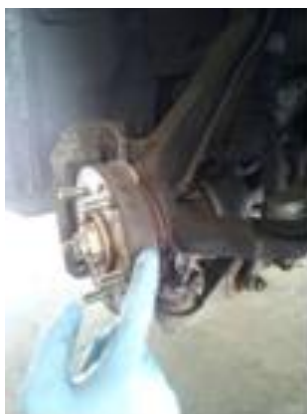
This is the hat section of the rotor still attached to the wheel hub. Notice the actual braking surface or plate is totally missing

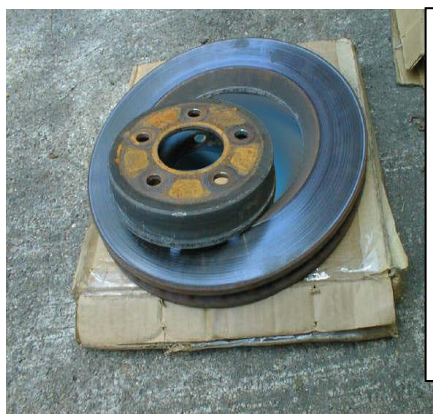
This is the hat and plate completely separated. Poor casting or not following OE design may have caused this.

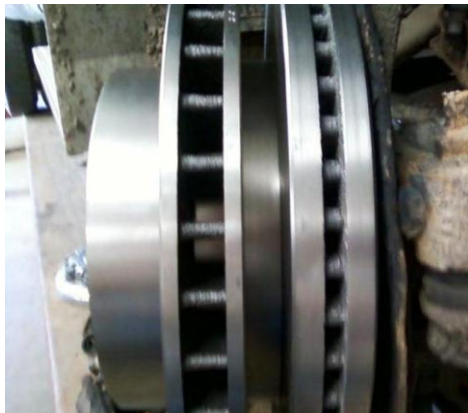
We have actually weighed our rotors and compared it to some of our competitors. In some cases we've seen over 20% weight reduction by eliminating vanes, increasing airgap between plates and not using OE design.

Here is an example of a poorly designed lightweight truck rotor next to ours. Would you install the rotor on the left on your customer's truck?

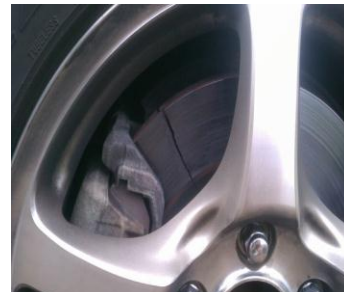
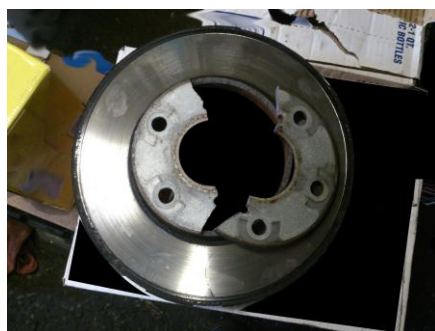
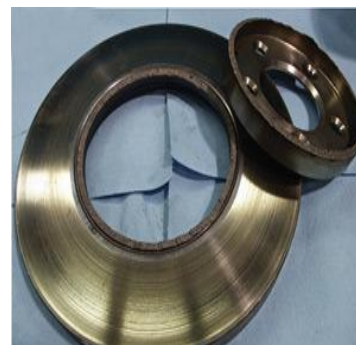
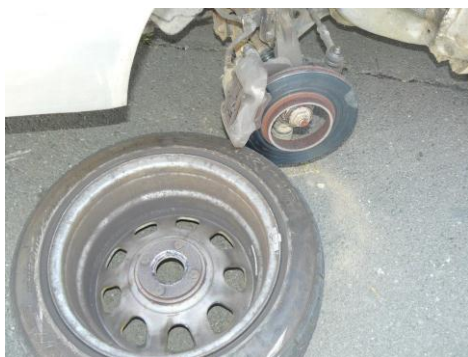
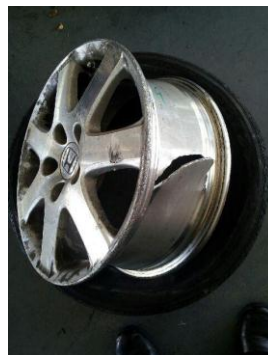
There is usually other damage to the vehicle. In this case the tire and wheel. Body damage occurs when tire contacts fender.
