Raybestos Bulletin 18-17

Brake Pedal Pulsation Cause

Date: 10-23-18

Condition: Pedal Pulsation

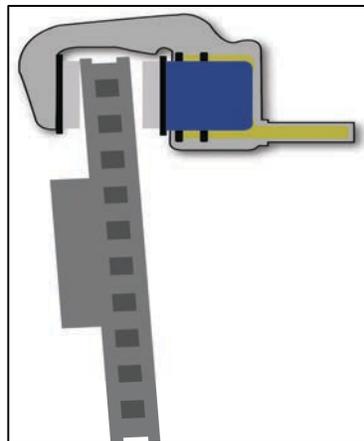
Image 1

If the runout is excessive, the rotor will begin to make contact with the brake pads as it wobbles back and forth (See Image 1).

This contact between the rotor and brake pads won't be constant. It will happen periodically as the rotor wobbles back and forth.

- 1.) Clean the hub
- 2.) Install the rotor and conical washers
- 3.) Torque lug nuts down to specifications. Specifications are found in a specification guide or the vehicle's service manual.
- 4.) Install dial indicator
- 5.) Check lateral runout by spinning the rotor. Specifications are found in a specification guide or the vehicle's service manual.

There are a few options you can choose from to correct lateral runout. The first option is to machine a rotor with a bench lathe or an on-the-care lathe. The other option is to replace the rotor with a new rotor.

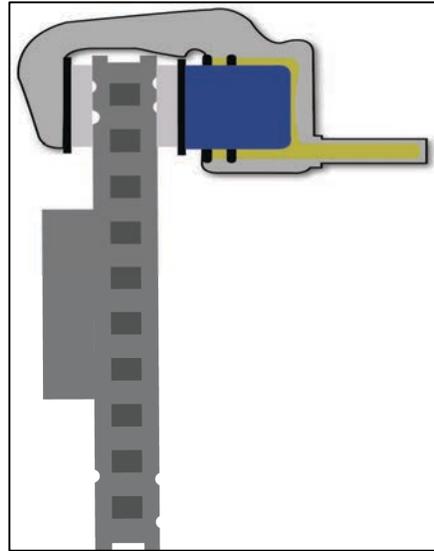
Image 2

If you use a semi-metallic pad, the pads will begin to grind away on the spots of the rotor that it contacts (See Image 2).

This happens because a semi-metallic pad has an abrasive effect on rotors.

Either way, this contact with the rotor is what causes a thickness variation. As the portion of the rotor with the DTV passes past the brake pads, the caliper piston has to extend or compress. This causes the pressure of the brake fluid to rise or fall during braking. This change of pressure is what leads to pedal pulsation.
