No. BPI 09-15

Subject: Slow speed ABS false modulation. This is a revision of bulletin 02-02 as indicated in the last paragraph.

Vehicle Involved: SUV'S, Light and Medium Duty Trucks. All vehicles that incorporate wheel speed sensors in steering knuckle and differential housings.

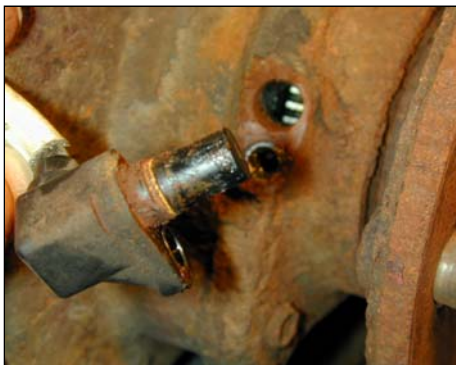
Fig. 1

Condition: Rust build up underneath the wheel speed sensor increases air gap, reducing the signal frequency. Low resistance value wheel speed sensors are particularly sensitive to air gap differences, resulting in slow speed false modulation.

Repair Procedure: Remove wheel speed sensor retaining bolt and sensor from hub / knuckle. With a wire brush, clean any rust or corrosion from the mounting surface. At the sensor, carefully remove the buildup of rust, corrosion, or debris. Clean the hole that the sensor fits into.
