Raybestos Bulletin 20-01

## Pedal Pulsation Caused by Moisture Buildup

**Vehicles Involved:** Disc Brake Vehicles

**Condition:** High-Speed Pedal Pulsation

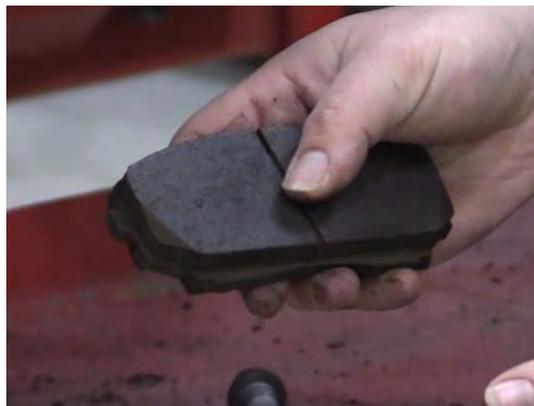
**Image 1**

When looking at the life of the two pads, the outboard pad had plenty of life left on it (See Image 1). The inboard pad was almost worn down to the backing plate. Additionally, it had grooves on the friction surface (See Image 2).

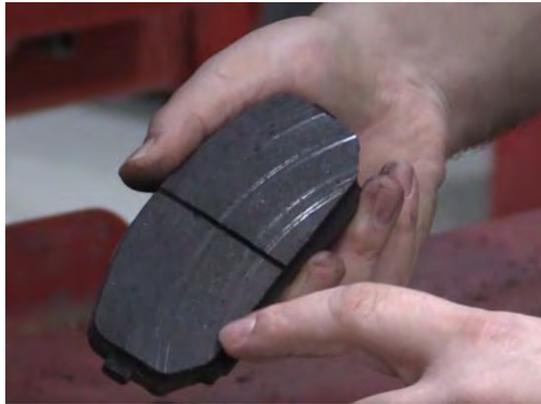
**Image 2**

After removing the caliper, we found that the inboard pad seized in the caliper on both front wheels. Excess moisture caused rust buildup in the caliper bracket. This rust wasn't as prominent on the outboard pad because it received consistent airflow through the wheels.

The excessive wear on the inboard pad was due to it seizing in the bracket. The pad was stuck in place up against the rotor, causing it to wear down at a quicker rate than the outboard pad.

Second, we will make sure to lubricate any metal-to-metal contact points in the system. This includes the areas where the pads contact the caliper bracket. This will prevent the pads from seizing in the caliper in the future.

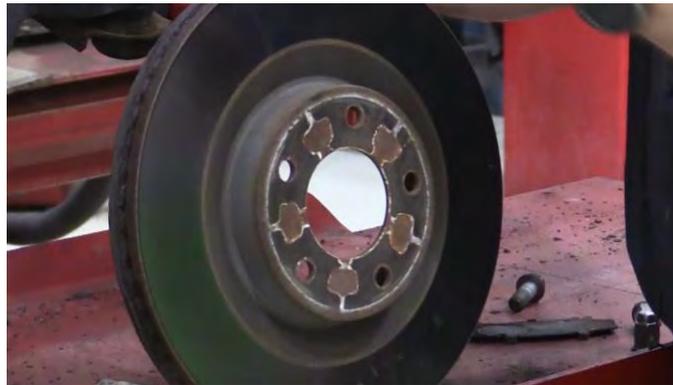
**Image 3**

Like the friction, the rotor surface told a different story when looking at the outboard versus the inboard. As mentioned, the outboard surface of the rotor looked fine. The surface was clean. There wasn't much if any rust buildup (See Image 3).

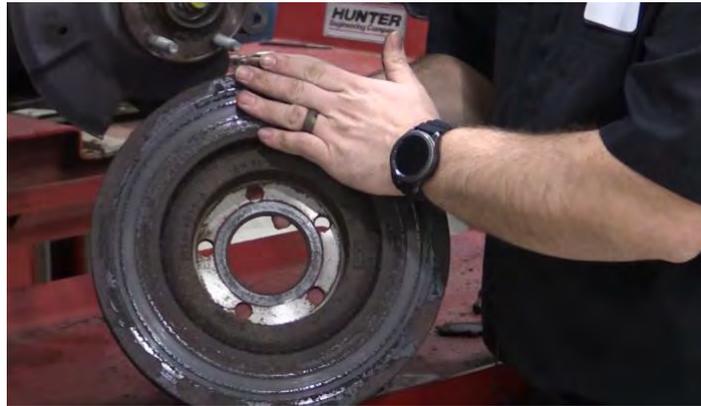
**Image 4**

However, the inboard side of the rotor was a mess. Rust buildup was prominent on the inboard surface. Additionally, the inboard was showing signs of a condition known as rust jacking (See Image 4). Rust jacking can occur on rotors when paired with ceramic friction. Ceramic brake pads leave a thin layer of material on the rotor's surface when applied.

When excess moisture builds up on the rotor's surface, it can creep under this friction layer. Over time the moisture will cause some of that material to pop off the rotor. This leads to an uneven surface on the rotor. This is otherwise known as a thickness variation.

This thickness variation caused the high-speed pulsation that brought the vehicle into our shop. Since the vehicle was sitting around in the Chicago elements with a lot of rain, snow and sleet, it makes sense that the moisture buildup would lead to this problem.

There are two steps we will take to prevent this problem in the future. First, we will put coated rotors on the vehicle. Coated rotors help protect against the damaging effects of rust and corrosion. The coating protects the edges of the rotor surface (See Image 5). This prevents moisture from creeping under the friction layer, which leads to rust jacking.
