**Bulletin BPI 12-01**

**Subject:** Importance of On-Vehicle Brake Lathe Use

**Vehicle Involved:** All Late-Model Vehicles

**Condition:** Vehicles prone to brake pulsation

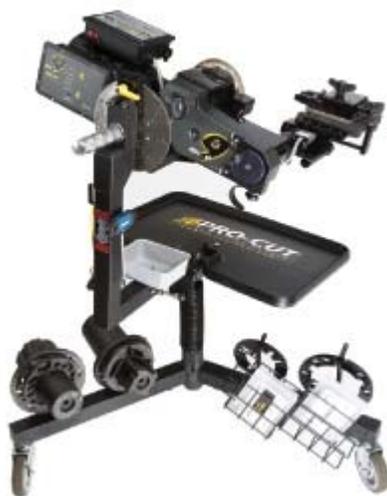
OEMs have ample resources for identifying problems and providing solutions for their customers' satisfaction. Recent Technical Service Bulletins provided by Honda, Hyundai, Mazda, and Volkswagen address the issue of brake pulsation and stress the use of the on-vehicle brake lathe **exclusively** for rotor resurfacing. They no longer recommend **any** off-vehicle rotor machining.

The reason for this is to account for the runout in the rotor, hub flange, wheel bearings and the surface condition of the mating surfaces of the hub flange and rotor. The goal is to achieve .002" lateral runout or less, as installed on the vehicle.

As with all brake work, inspection of the rotors for cracks, severe discoloration or corrosion, and measurement of the thickness of the rotor should be performed. This is to ensure the rotors are serviceable before proceeding. After inspection, careful cleaning of the mating surfaces with the proper surface-conditioning discs and tools is important before machining operations are begun.

Follow the lathe manufacturer's instructions for setup and machining operation. Also important is to maintain the cutting tools as recommended to ensure the quality of the finish that is produced by the lathe.

After machining, clean the surface with hot, soapy water and a brush to remove any loose machining grit. Before removing the lathe hub adapter from the rotor, measure the thickness of the disc to ensure it is still above minimum thickness and recheck the lateral runout to see that it is within the .002" specification.
