Bulletin BPI 02-17

Subject: ABS Equipped Vehicles / On car Lathe

Vehicle Involved: All Vehicles

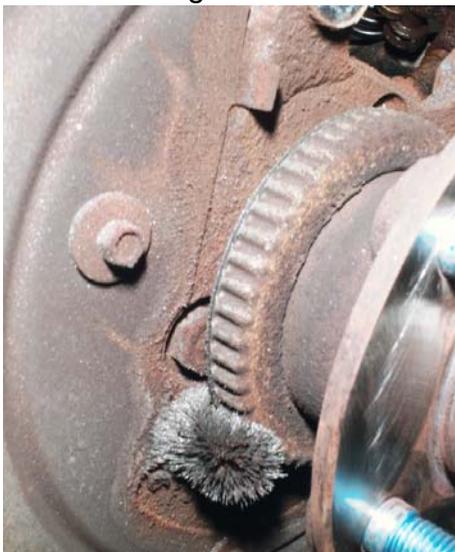
Fig. 1

All Anti-Lock brake systems utilize speed sensor inputs. Some of these systems have very narrow tolerances in regard to wheel speed data. Speed sensor concerns include air gap that can easily be altered during the course of brake maintenance. When using an on the car brake lathe it is important to prevent metal shavings from contacting and collecting on the sensor. The sensor is a magnet with a coil of wire wrapped around it. Metal filings or shavings from the on car lathe naturally are attracted to the magnet reducing the air gap. See figure 1. This may or may not illuminate the ABS warning light. Metal shavings may even cause intermittent or false ABS brake modulation. Additional speed sensor concerns are reviewed in Bulletin 94-18.
