Bulletin BPI 13-05

Subject: : Checking Rotor Run-out Correctly

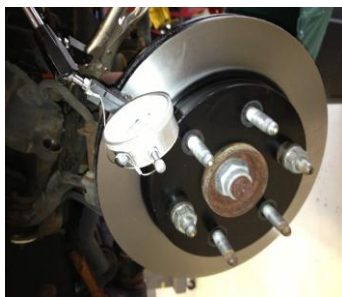
2 lug-nuts: **.005** run-out

Installing 2 or 3 lug-nuts would have forced us to try and correct run-out but in reality there was nothing to fix. This rotor was within specification when checked correctly.

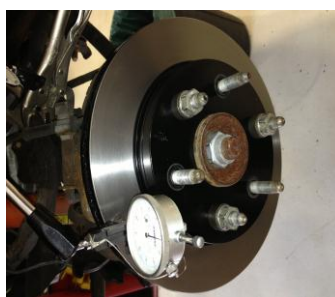
3 lug-nuts: **.003** run-out

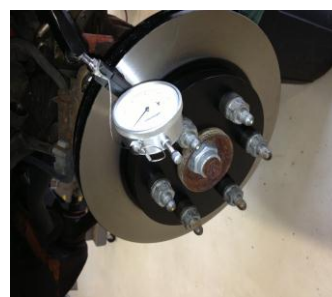
All lug-nuts: **.002** in specs
