## 17-01: Problems Caused by Corrosion on Rotors

**Date:** March 27<sup>th</sup>, 2017

**Vehicles Involved:** All

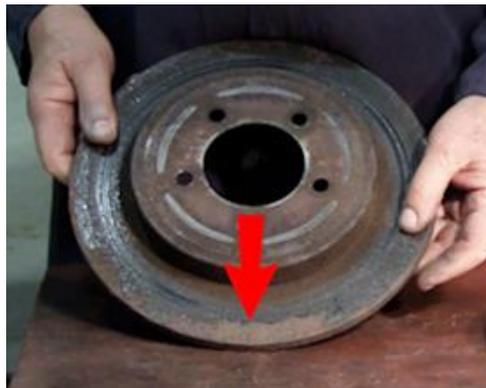
### **Rust Jacking Example:**

Modern brake pads transfer a thin layer of friction material onto the rotor's surface when applied. We call this the friction material layer. Over time and mileage, corrosion and moisture begins to creep from the unswept areas into and under the friction material layer. Eventually, that moisture can cause the friction deposits to flake or pop off. This can lead to a condition commonly known as rust jacking or edge lift.

Rust jacking causes your rotor to wear unevenly, which may lead to a thickness variation of the rotor. This will result in an excessive lateral runout leading to pedal pulsation.

While there is no way to stop corrosion completely, coated rotors help protect your rotors from the damaging effects of corrosion.

Raybestos RPT Rust Prevention Technology™ rotors are coated with a full Grey Fusion 4.0™ coating. The entirety of the rotor's surface is coated, including the cooling vanes. This helps to protect against the spread of corrosion.

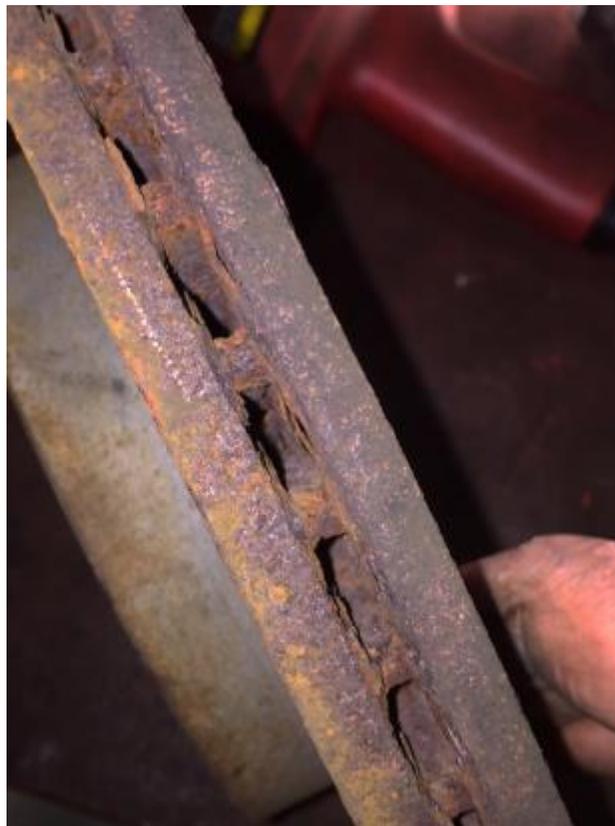
### **Vanes after three Chicago winters:**

Corrosion will develop in the cooling vanes. Over time and mileage, rust buildup can restrict or block the airflow through the vents, which can lead to the rotors overheating. Overheated rotors can affect the ability of the brake pad to generate enough friction. This can lead to a reduction or complete loss in braking power, which is known as brake fade.

As you can see in the picture below, three winters on the roads of snowy Chicago caused the vanes of this rotor to become severely corroded. This will restrict airflow and affect the ability of the rotor to cool properly.

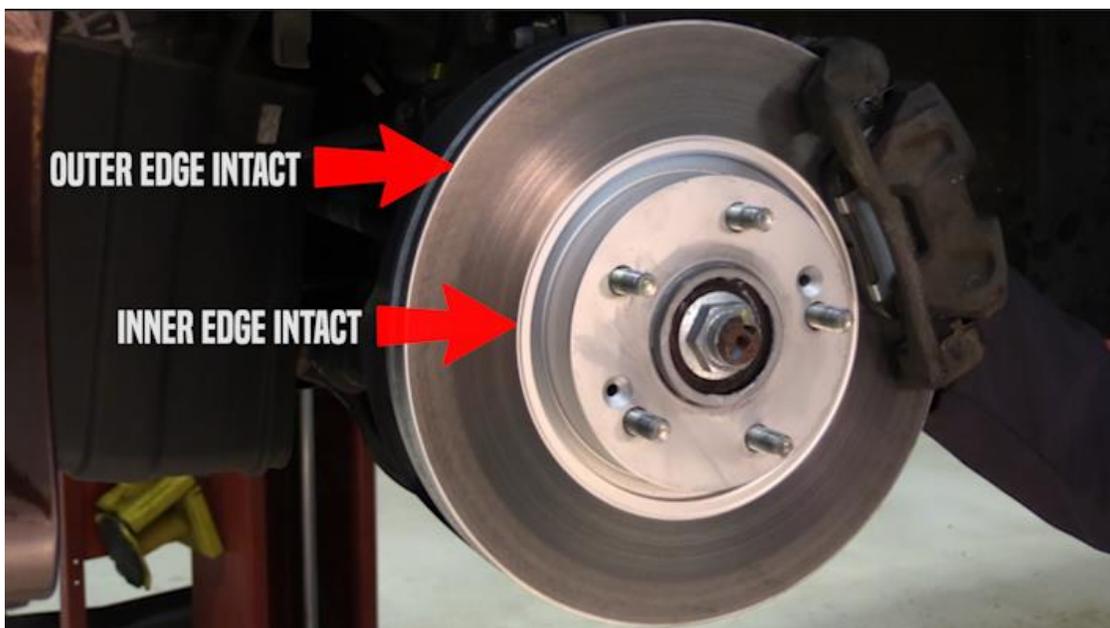
### Raybestos coated rotor after a test drive:

It is important to note that the coating in the pad swept areas disappears quickly after installation. This is normal. The coating on the inner and outer edges of the rotor's surface remain intact. This prevents the corrosion from creeping under the friction material layer and protects your rotor from rust jacking.

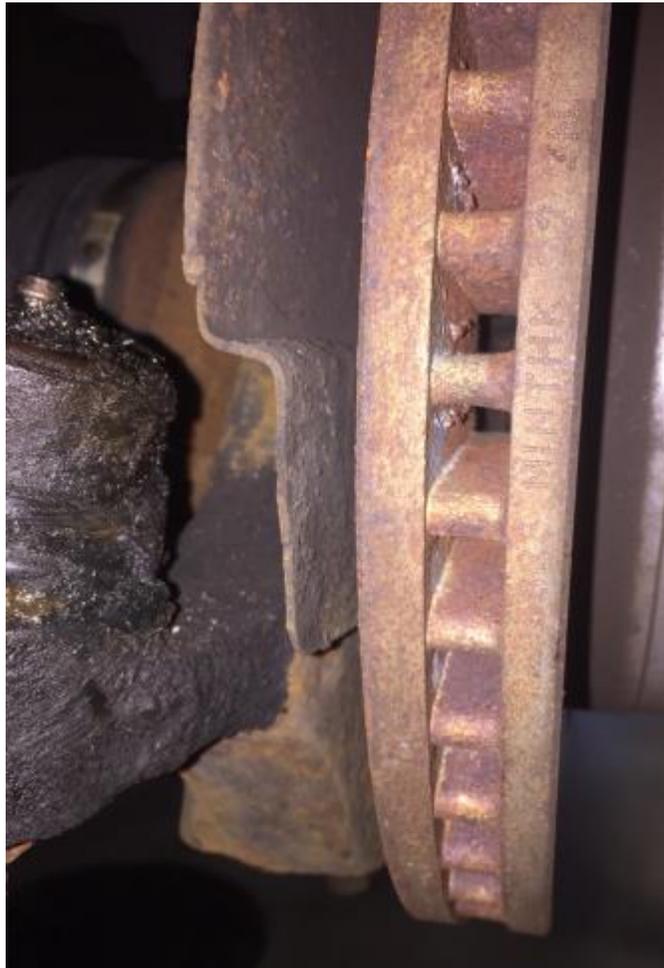
**Coated vanes after two Chicago winters:**

Additionally, the coating helps prevent corrosion and rust from building up in the cooling vanes. This allows air to flow smoothly through the vanes and keeps the rotor cool.

As you can see in the image alone, there is minimal rust and corrosion present in the cooling vanes after two Chicago winters on the road. There is nothing present to restrict airflow throughout the vanes.
