Bulletin BPI 13-10

Subject: Reading rotor wear patterns

Vehicle Involved: All

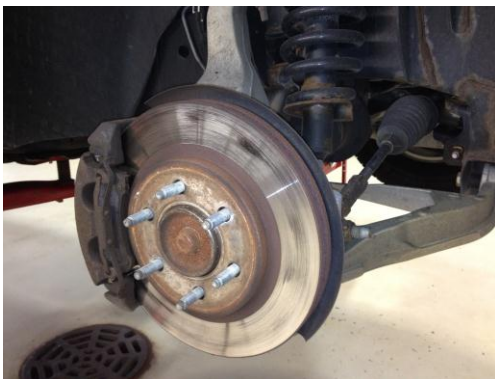
Condition: Rotor looks to have “hot spots” on surface

Repair Procedure: Through the years, the brake industry has gone thru many changes. Before ceramic brake pads become popular, all of our brake pads were abrasive style and wore the rotor eventually to discard. Ceramic pads on the other hand, are adhesive style and actually rely on material from the pad transferring to the rotor. This material transfer starts day one and is constantly leaving material on rotor face. On a rotor with proper run-out, the material is transferred evenly causing what looks like a bluing pattern completely across face. If the rotor has excessive run-out, the material is left in blotches (see figure 1). These spots of material cause a slip-stick action, especially under light braking. This uneven material transfer can also occur from caliper pistons not returning, rusted or sticking slides or worn hub bearings.

The material transfer can cause other issues such as rust jacking. Moisture gets under the transferred material and lifts the ceramic material off in flakes. We often condemn the rotor but in some cases, the flakes are all friction material. The ceramic pad typically uses some aggressive material to help maintain equal transfer. Copper was one such material but is being phased out due to environmental concerns.

Following manufactures run-out and torque specs and checking all related parts such as bearings and calipers should prevent your brake jobs from coming back with this issue.
