## 17-02: Problems with Corrosion on Calipers

**Date:** April 28th, 2017

**Vehicles Involved:** All

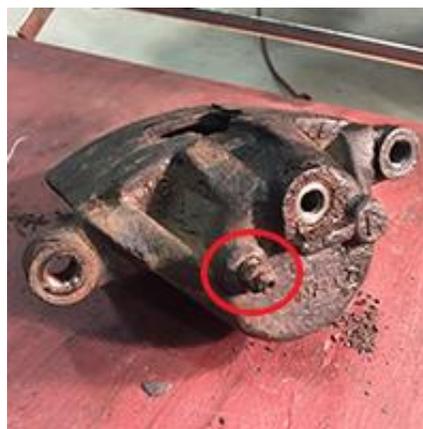
#### Outboard Side

Corrosion on and around the bleeder screw can result in the screw binding to the caliper. Binding makes the screw difficult to remove or even causes it to snap during removal.

Corrosion can also cause the banjo bolt to seize to its housing, stripping the bolt or caliper threads when removed.

### **Zinc Coating on Outboard Side of the Caliper**

The areas around the bleeder screw and banjo bolts are coated with our zinc plating. This prevents corrosion in these areas, making it easy to remove during servicing.

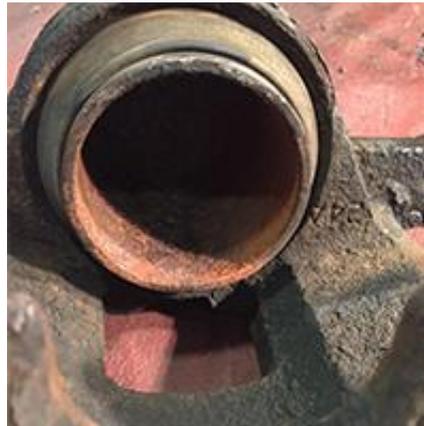
## Inboard Side

Rust that undercuts or damages the sealing area of the piston boot may result in water leaking into the bore region of the caliper.

Additionally, corrosion surrounding the piston and its seal can cause the piston to bind to the caliper body. This binding condition affects the ability of the piston to cycle back and forth and release the brake pads.

### **Zinc Coating on Inboard Side of the Caliper**

The rims of the piston bore and all sealing surfaces are plated to prevent rust from undercutting the sealing surface. This prevents water from entering the bore region of the caliper and also protects the piston from binding to the caliper body.

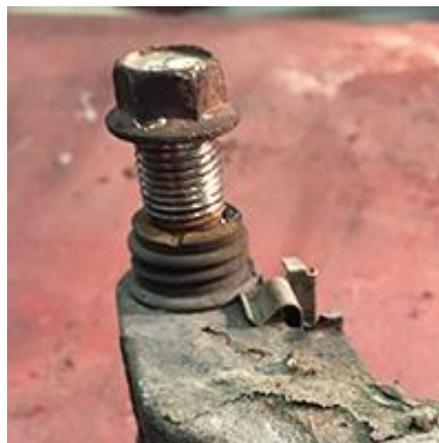
### Caliper Guide Pins:

Caliper guide pins are responsible for guiding the brake pad to meet the rotor at a proper angle. When the pins become corroded, they can bind to the slides. This binding condition affects the ability of your brake pads to make proper contact with the rotor, resulting in uneven pad wear.

### **Zinc Coating on Caliper Bracket**

The entire caliper bracket is coated with our zinc plating. This protects against corrosion and prevents brake pads from binding to the caliper bracket.

Finally, pre-lubricated slide pins and new rubber components help keep your guide pins sliding freely.

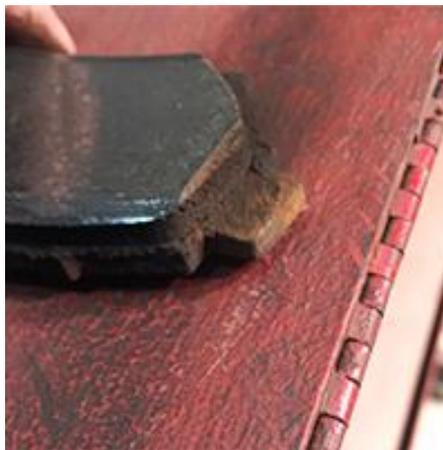
## Brake Pads & Abutment Clips:

The edges of brake pads where the pad meets the caliper bracket are prone to rust and corrosion.

When corrosion builds up on the edges of the pads, on the abutment clips or on the area under the abutment clips, it can cause the pad to bind to the caliper bracket. This affects the ability of the pads to move freely within the caliper housing and make proper contact with the rotor. This may result in a variety of issues, including brake pull, premature wear and brake noise.

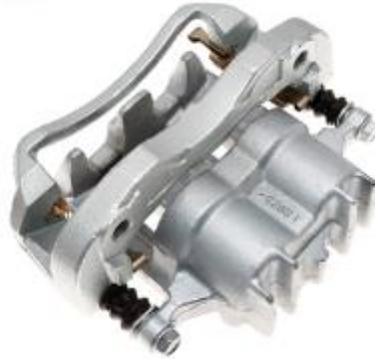
Raybestos RPT Rust Prevention Technology™ plated calipers are coated with a zinc electroplating on all cast iron housings and brackets. This differs from a lot of our competitors who use a powder coat on their calipers.

- Zinc plating fights corrosion even if the coating is scratched to the caliper surface. Powder coating does not.
- Zinc plating adds virtually no thickness to the part. Powder coating does.
- Zinc plating has superior heat transfer properties over powder coating.
- Zinc plating is resistant to brake fluid. Powder coating is damaged by it.
