Raybestos Bulletin 20-02

The Importance of Using OEM-Matched Aftermarket Pads

Vehicles Involved: Disc Brake Vehicles

Condition: Lip Formed on Front Brake Pads

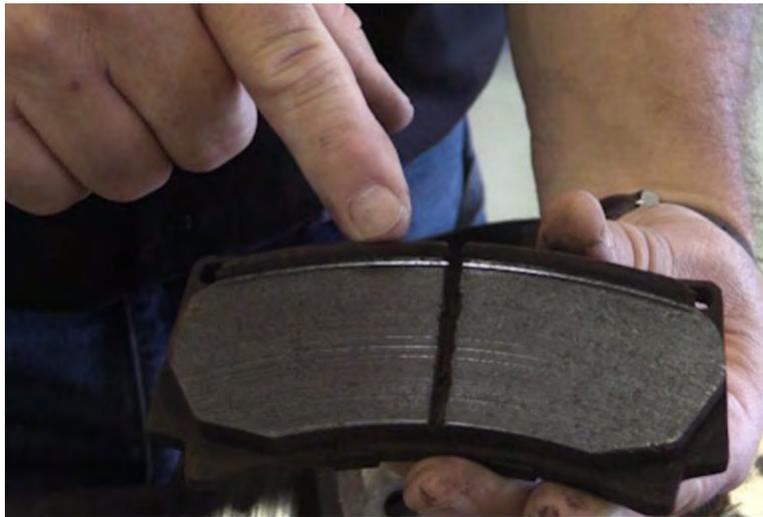
Figure 1

We were recently doing a brake job on a Hummer H3. When we pulled the front pads off, we noticed that one of the pads was not making proper contact with the rotor. Part of the pad was riding higher than the rotor, which caused a lip to form on the pad (See Image 1).

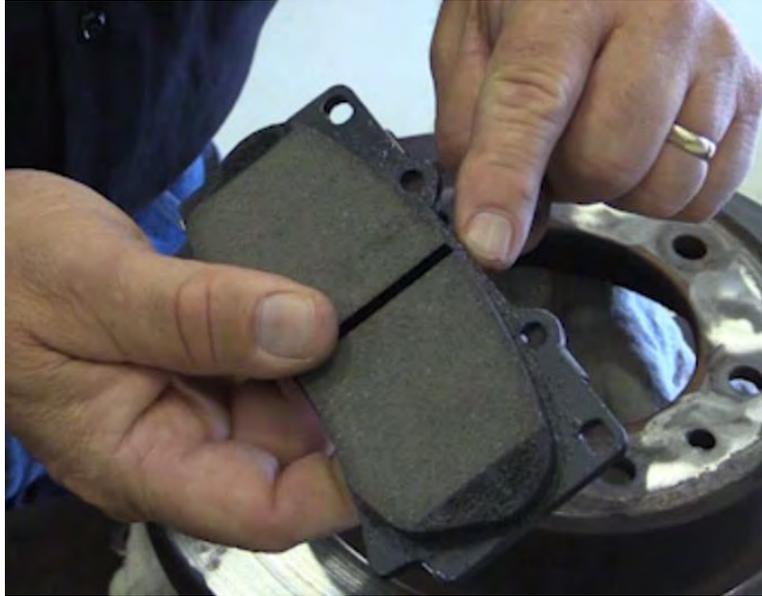
Figure 2

At first glance, the pads looked fine. The backing plates were OE-matched. The shape was right. However, we noticed that the friction puck itself rode up to the top of the backing plate.

Looking at our Raybestos OE-matched pads, we noticed about a quarter-of-an-inch gap between the puck and the top of the backing plate (See Figure 2). That extra quarter of an inch of friction material on the old pads caused improper pad-to-rotor contact.

This is a great illustration of why it's important to buy from quality manufacturers like Raybestos. We take the time to study OE pads and manufacture our pads to ensure proper fit, form and function.
